S-390 Dr. Bevans' House Princess Anne private c. 1900-1910

## Maryland Historical Trust State Historic Sites Inventory Form

Survey No. S-390
Magi No. 2003905704
DOE \_\_yes \_\_no

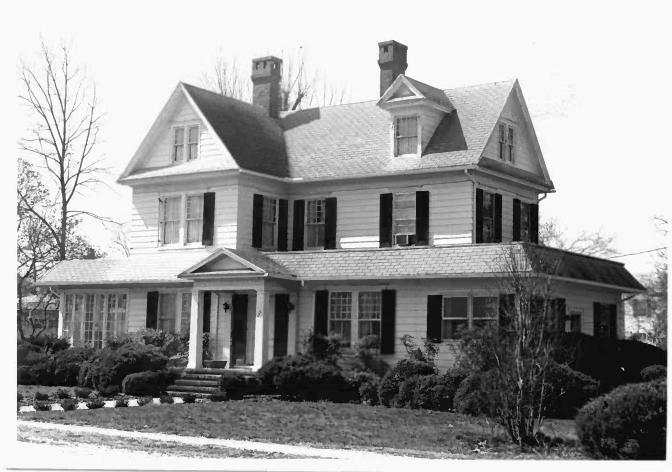
Dr. Bevan's House S-390 Princess Anne, Somerset Co., Md. Northeast Elevation 4/86, Paul Touart, Photographer Neg./Md. Historical Trust

The east (main) elevation is an uneven three-bay elevation with a center entrance and flanking multi-pane sash windows. Covering the first floor is a single-story enclosed porch with a double-door entrance flanked by a series of large and small multi-pane windows. The entrance bay is marked by a gabled Tuscan column porch. Unlike the first floor, the second floor retains an uneven facade with a projecting south gabled bay and two recessed northern bays. A pair of multi-pane sash windows light the second floor of the two-story bay, while a smaller pair of windows illuminate the attic. The gable is defined by a pediment. The northern two bays are marked by single multi-pane sash windows, and the roof is pierced by a gabled dormer. Two interior brick chimneys rise from the center of the house.

The north gable end of the tee-plan is covered on the first floor by the enclosed porch addition, and the second floor is defined by two multi-pane sash windows. The gable end is finished with the same pediment found on the front of the house, and the attic is lighted by a paired multi-pane sash window.
